# **Mobile Pentium® II Processor Specification Update**

Release Date: September 1998

Order Number: 243887-002

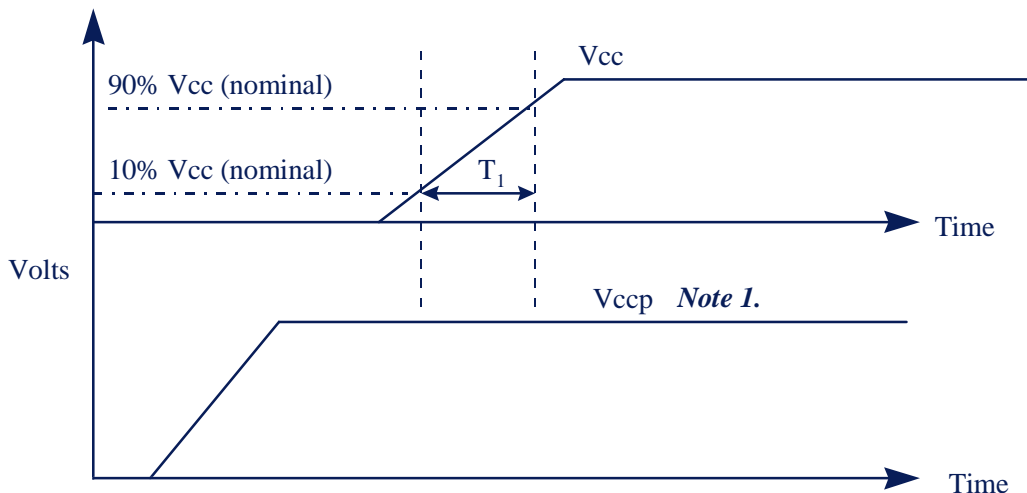
**Figure 1.  $V_{CC}/V_{CCP}$  Timing Requirements (Mobile)**

**PROBLEM:** The processor uses the PWRGOOD signal to ensure that no voltage sequencing issues arise; no pin assertions should cause the processor to change its behavior until this signal is asserted, when all power supplies and clocks to the processor are valid and stable. However, if  $V_{CC}$  ramps up before  $V_{CCP}$ , it will cause the processor to enter an invalid state.

**IMPLICATION:** If this erratum occurs, the system may boot normally however, the L2 cache may not be initialized.

**WORKAROUND:** For Mobile Pentium II processors, ensure that  $V_{CC}$  ramps after or with the L2 cache IO voltage ( $V_{CCP}$ ). If  $V_{CCP}$  ramps after the  $V_{CC}$ , a delay circuit can be placed on the core  $V_{CC}$  to ensure that  $V_{CC}$  ramps at the same time or after  $V_{CCP}$  as shown below in Figure 1.

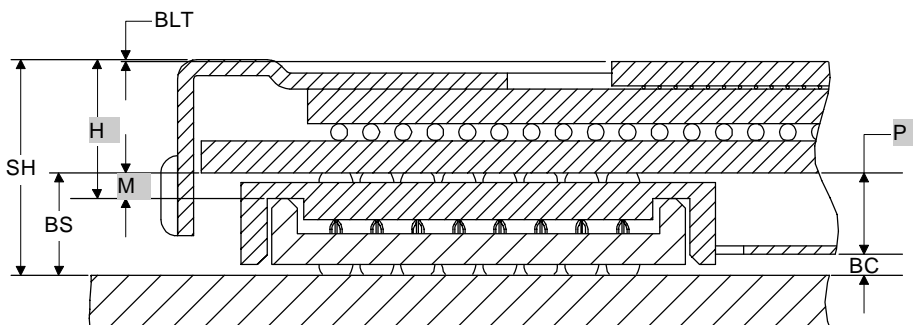
Figure 5.6. Cross Sectional View With Vertical Dimensions

### 13. Misabeled Vertical Dimension Parameters

Figure 5.6 in the *Mobile Pentium® II Processor at 233 MHz and 266 MHz* datasheet should be replaced by the following figure:
